TLGU 10

## SKF Ultrasound Lubrication Checker

Ultrasonic sensor improves maintenance practices when re-lubricating bearings

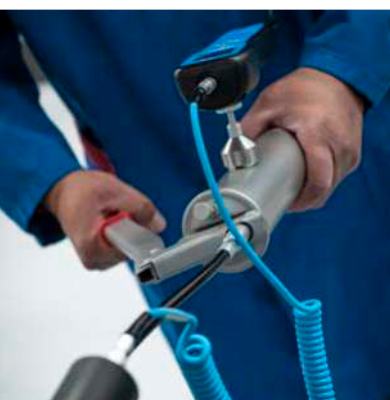
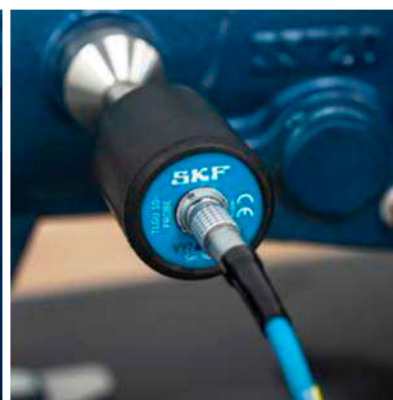
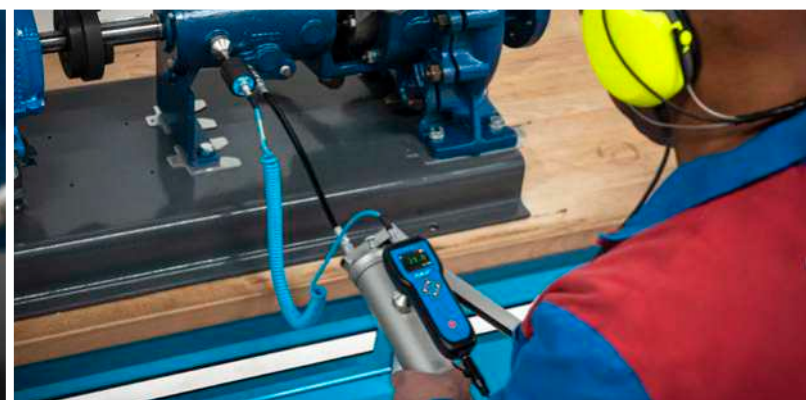
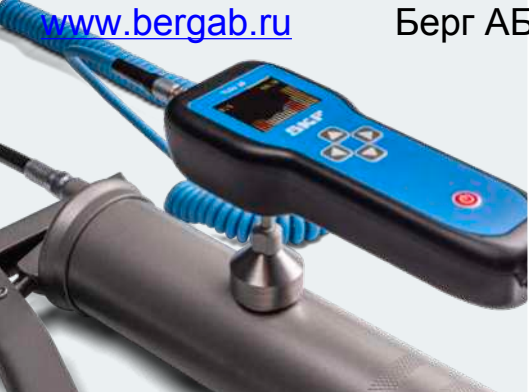
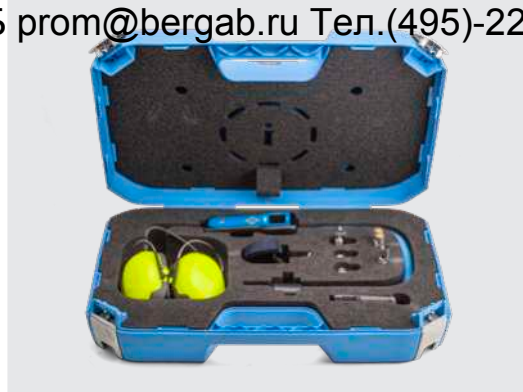
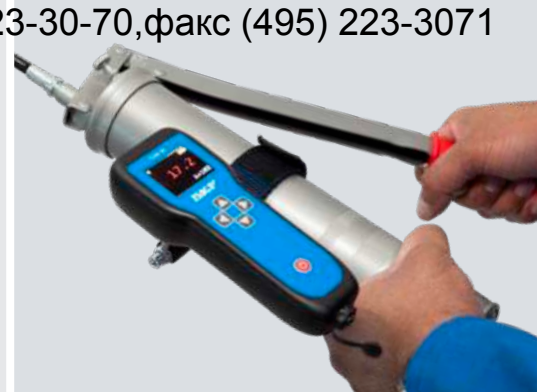
The device is simple to use, and relies on a robust, repeatable ultrasound sensor that is optimised for harsh conditions. The sensor monitors the sound of lubricant filling the bearing. Once connected to a grease gun, the

TLGU 10 allows a technician to listen to this sound, via headphones. The sound changes abruptly at the point where the correct amount of lubrication has been applied. In addition, a coloured display indicates noise levels for ease of use.
